AVIATION ACCIDENT INVESTIGATION REPORT

RUNWAY OVERRUN ON LANDING

FLIGHT AA331

BOEING 737-823

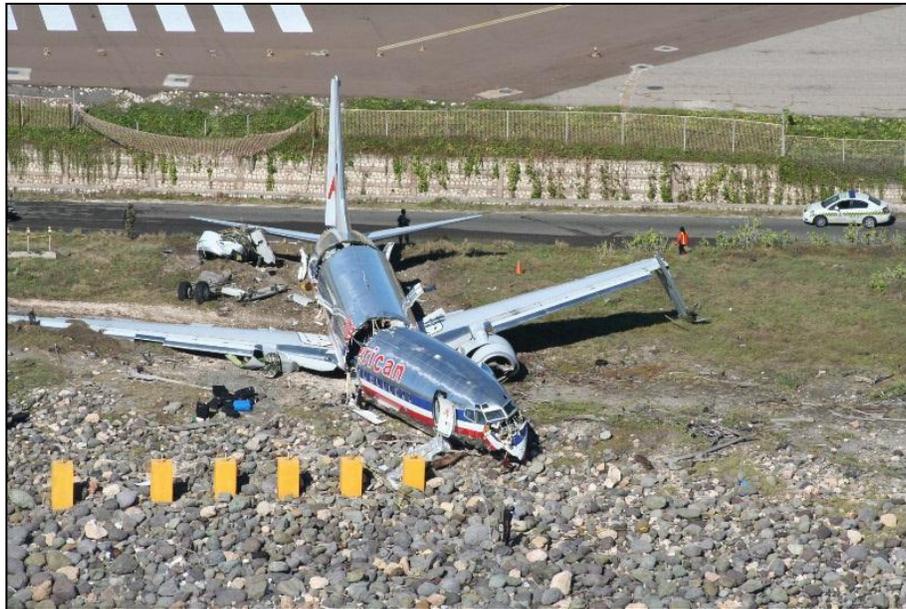
Photo 2 Aircraft Wreckage

The forward section of the aircraft came to rest on a track of 088 degrees magnetic and the centre and aft sections were on a track of 128 degrees magnetic.

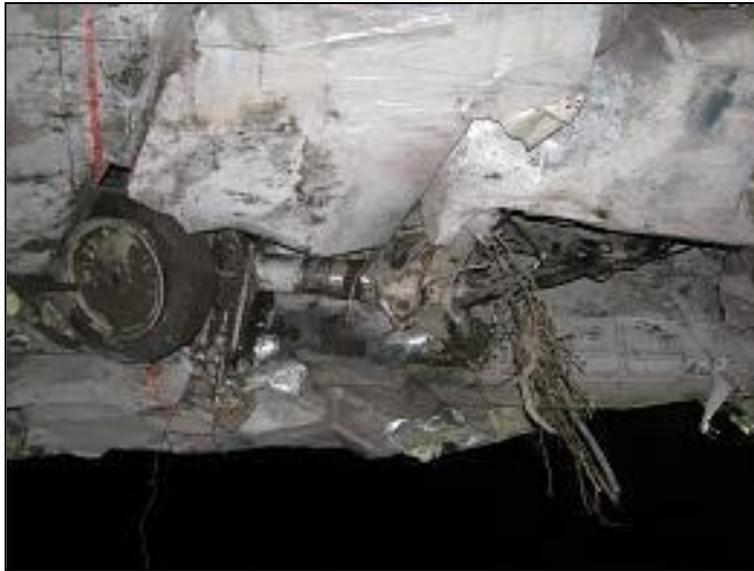
Photo 8 Nose Landing Gear

The nose gear was folded back by impact forces, but the FDR indicated that it was down and locked before impact. The wear on the tires was typical of in-service tires. The left tire pressure was 200 psi, and the right was 0 psi.

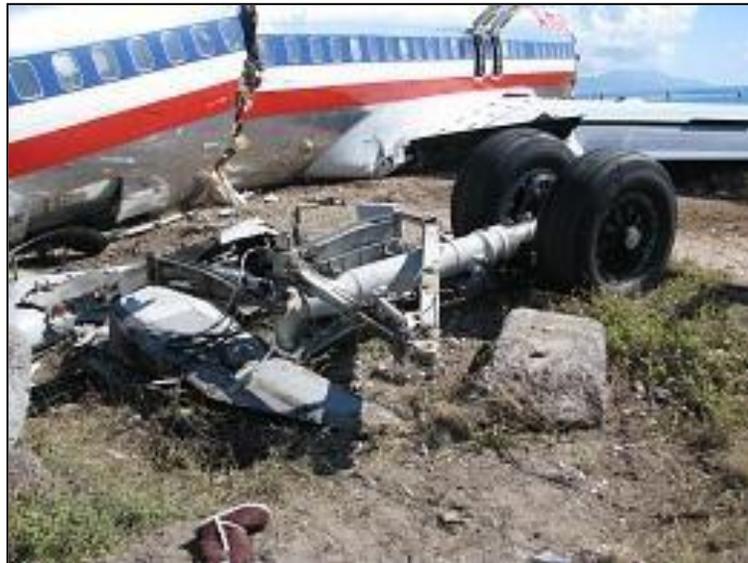
Photo 9 Right Main Landing Gear

13/32 inch and 7/32 inch, respectively. The measured tire pressure was 210 psi. The serial side shoulder rib had heavy abrasion and melted rubber balls 360° around the tire. The non-serial side shoulder rib also exhibited heavy abrasion and melted rubber balls 360° around the tire, however, there was not as much abrasion as on the serial side shoulder rib. The centre tread rib demonstrated typical abrasion wear for a rolling tire. There was some heavy abrasion on the shoulders similar to that identified on the shoulder ribs but very little evidence of melted rubber balls.

There was no evidence of pre-impact damage to, or pre-impact failure of, any part of the right main landing gear system, including the tires and the brakes.

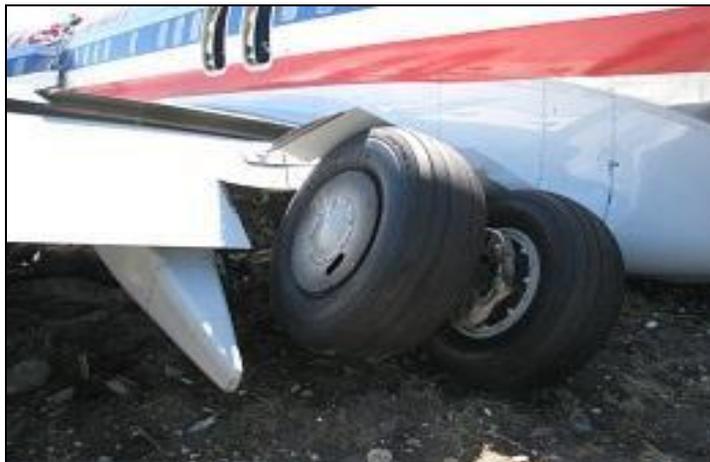
Photo 10 Left Hand Main Landing Gear

The outboard tire had retread level R2 dated 9/2009. The following measurements of the remaining tread depths were recorded (measured outboard to inboard): 6/32 inch, 12/32 inch, 12/32 inch and 2/32 inch. The measured tire pressure was 204 psi. Both side shoulder ribs had heavy abrasion 360° around the tire, but there was no evidence of melted rubber. The centre tread rib exhibited typical abrasion wear for a rolling tire.

There was no evidence of pre-impact damage to, or pre-impact failure of, any part of the left main landing gear system, including the tires and the brakes.

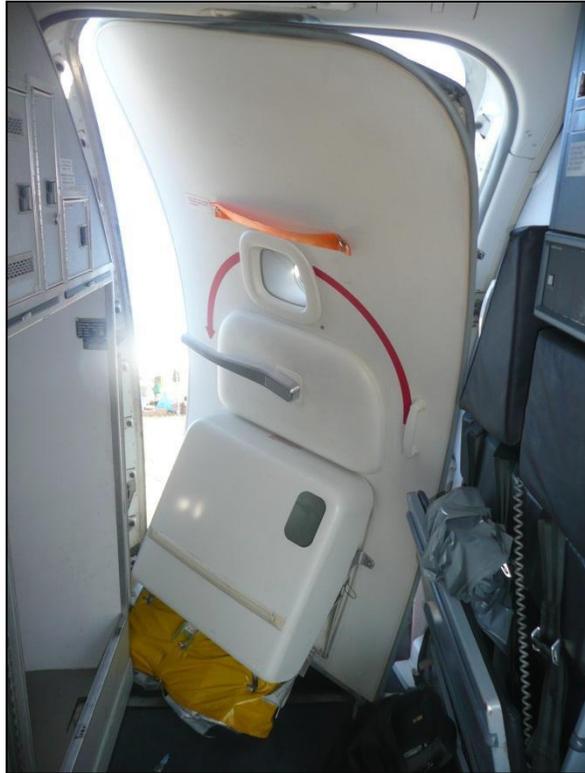
Photo 11 Forward Left Door (L1)

The escape slide pack was jammed into the doorway on the aft corner of the escape slide and was not able to fall free from the door sill ⁴⁵. Once the escape slide pack had been removed, the door was tested for operation. It was found to operate to the open position, but could not be fully closed in the locked position

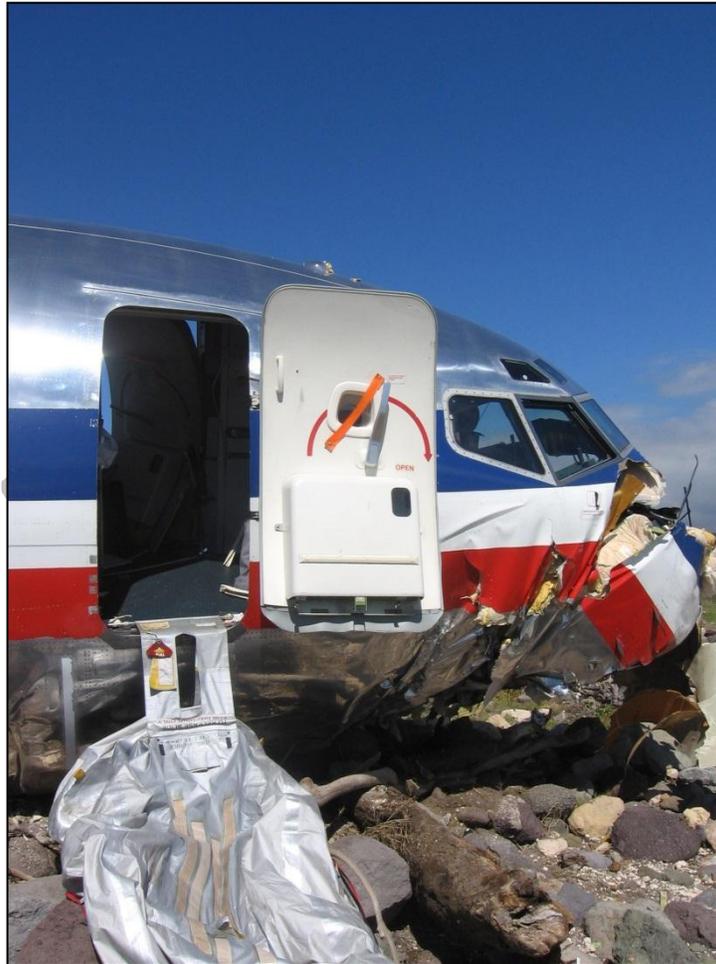
Photo 12 Forward Right Door (R1)

The escape slide pack had been released from the escape slide compartment. The escape slide was found deflated, but there was evidence that the slide had been inflated post impact.⁴⁶

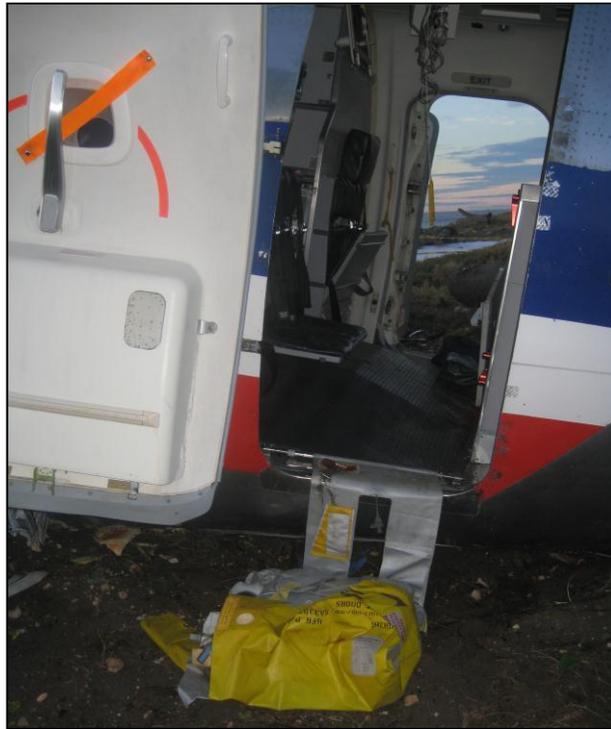
Photo 13 Aft Left Door (L2)

The L2 escape slide pack was found on the ground, released from the slide pack compartment, but the slide was not inflated.

After the accident the aft fuselage of the airplane was too close to the ground for the slide to fall far enough to activate the inflation mechanism.

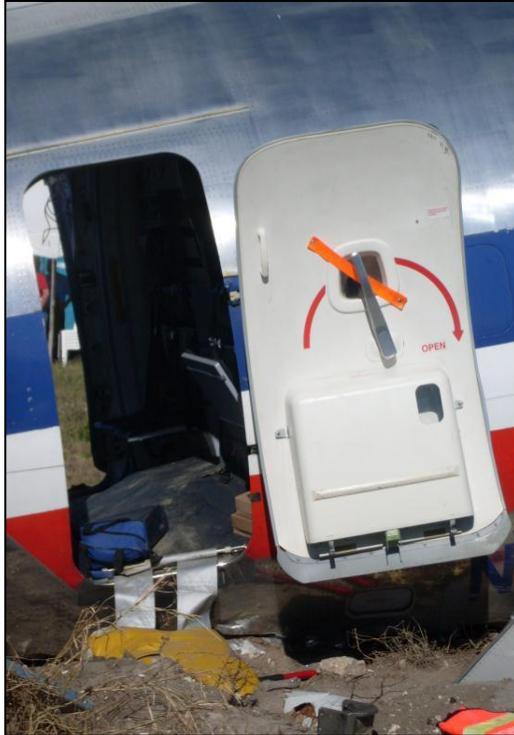
Photo 14 Aft Right Door (R2)

The R2 door was found in the fully open position with the handle positioned between the open and locked positions. The caution strap was found snapped across the viewing area. The operation of the door was checked and was found to open normally.

The R2 escape slide pack was found on the ground, released from the slide pack compartment, but the slide was not inflated. After the accident the aft fuselage of the airplane was too close to the ground for the slide to fall far enough to activate the inflation mechanism.

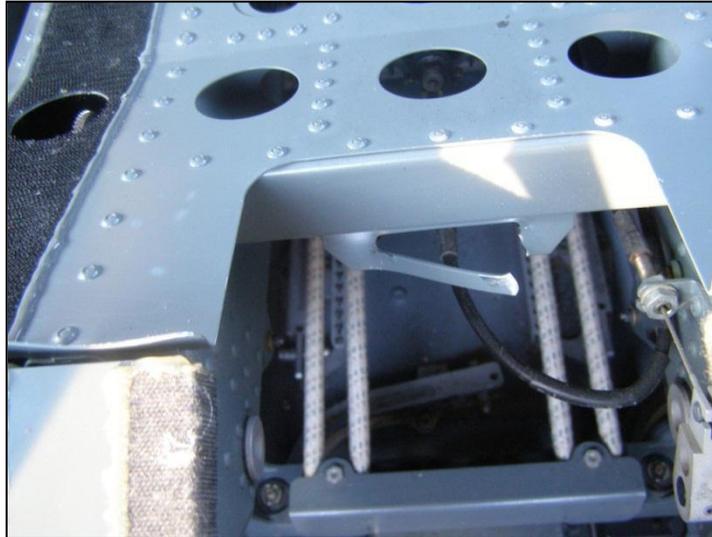
Photo 16 The captain's crotch belt bracket

The captain's seat crotch belt was found broken loose from the seat structure because the captain's crotch belt bracket was broken.⁴⁷ Both the crotch belt and the outboard shoulder harness were found buckled. The captain's outboard shoulder harness was locked in the extended position and the inboard shoulder harness retracted normally.

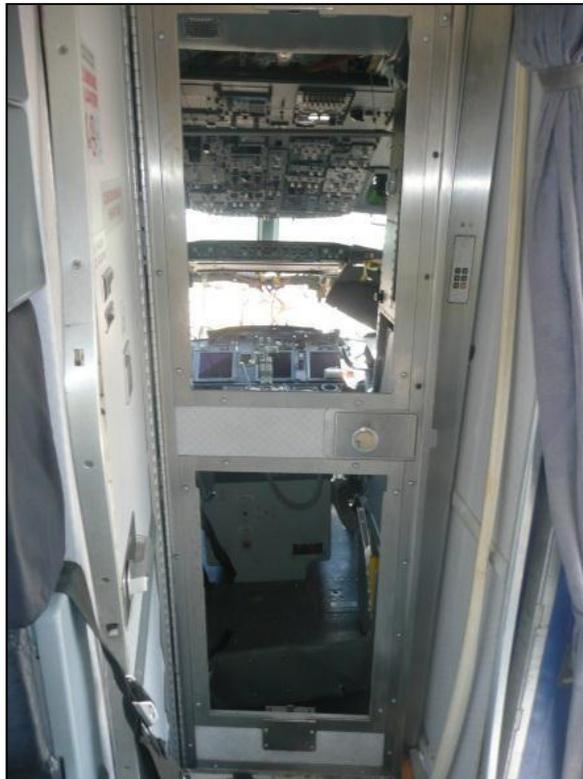
Photo 17 Flight Deck Door

The forward entry area floor buckled laterally about midway through the R1 doorway. The buckling continued clear across the cabin flooring from left to right. Most of the buckling was in the R1 entry area and in the aisle to the flight deck door.

In the galley area, forward of R1, it was evident that the structure was buckled, causing some items to be jammed in position. Both of the cabin crew members seated at L1 reported that they were unable to retrieve their flashlights because the doors to the emergency equipment compartments under their jump seats were jammed due to the buckling of the floor.

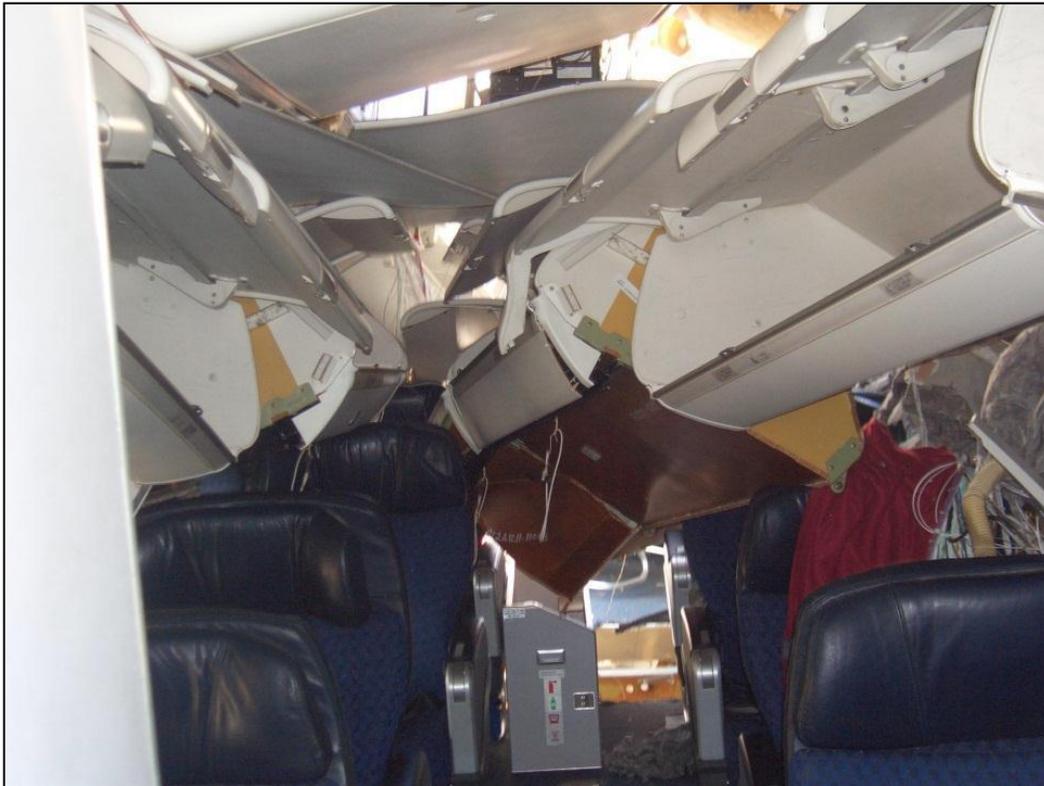
Photo 18 First Class Cabin

The interior of the forward section sustained the heaviest damage compared to the centre and aft sections. This section of the aircraft was angled about 40 degrees to the left of the centre section, leaving an opening on the right side about 6 feet wide, and no opening on the left side. The ceiling panels, overhead stowage bins, passenger service units (PSUs), and spacer panels were found displaced. The forward video monitor was stowed. The aft ceiling mounted video monitor remained attached to the stringer and the monitor shroud was displaced downward. The life raft was found in its stowage compartment in the ceiling above Rows 3 and 4. The attachments on the left side of the life raft compartment remained attached to the stringers, but the right side was detached from the stringers.

The majority of the seats in this area were in good condition, with exceptions throughout the section.

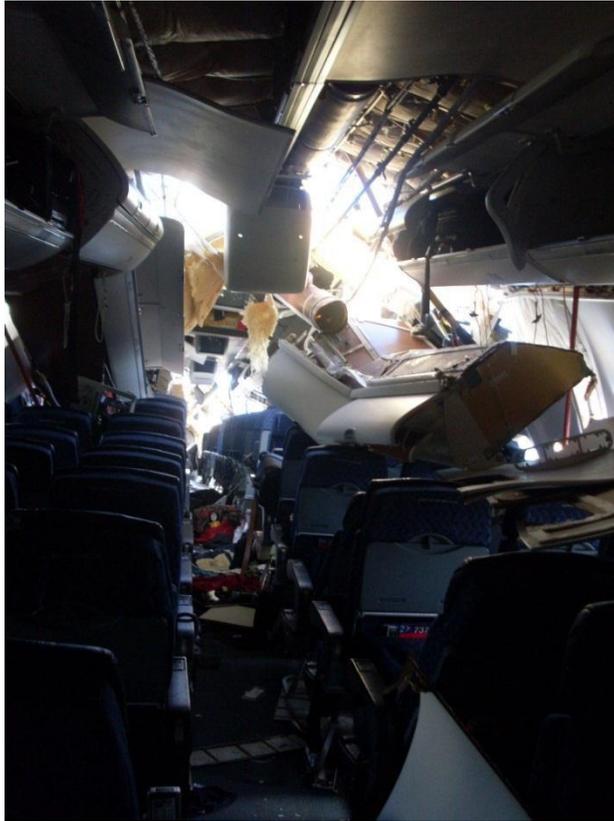
Photo 20 Aft Section

The aft-most portion of floor between the lavatories had buckled exposing a gap between cabin floor panels and the aft galley floor. The majority of the seats in this area were in good condition, with exceptions throughout the section.
