National Transportation Safety Board Aviation Accident Final Report

Location:	Amarillo, TX	Accident Number:	CEN17FA168
Date & Time:	04/28/2017, 2348 CDT	Registration:	N933DC
Aircraft:	PILATUS AIRCRAFT LTD PC 12	Aircraft Damage:	Destroyed
Defining Event:	Loss of control in flight	Injuries:	3 Fatal
Flight Conducted Under:	Part 135: Air Taxi & Commuter - Non-scheduled - Air Medical (Medical Emergency)

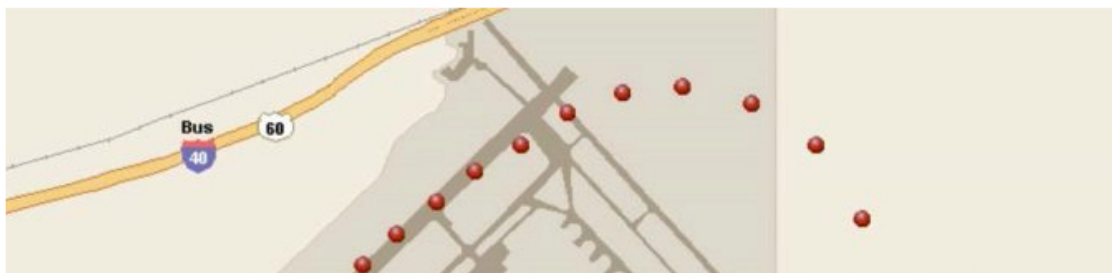
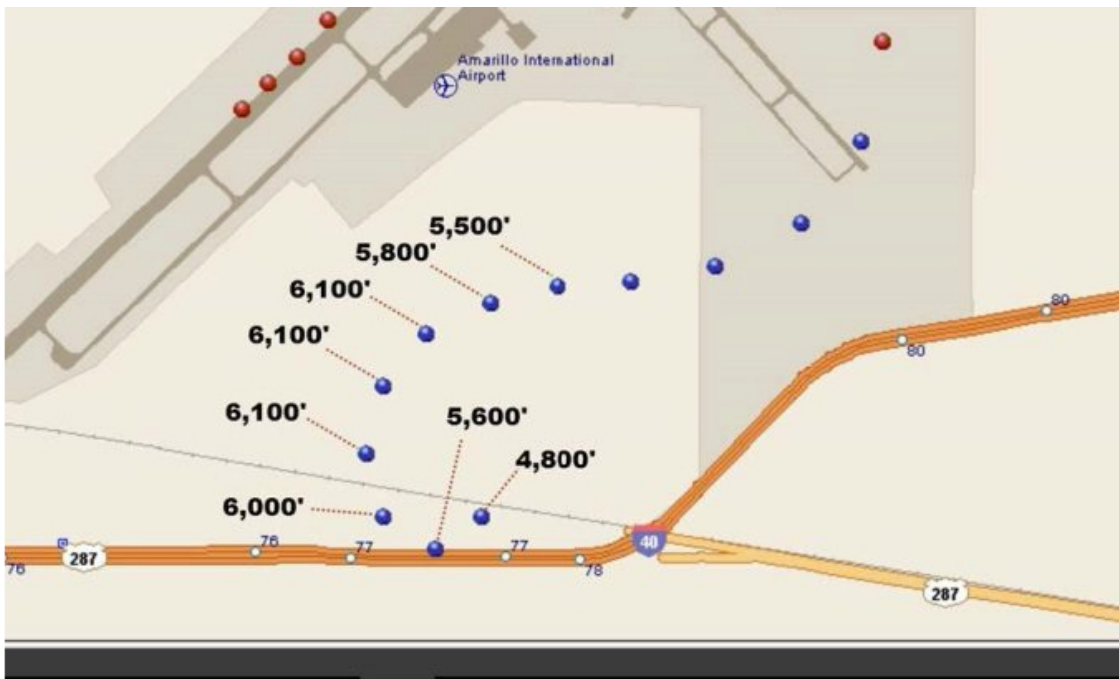
Figure 1 – Plotted radar data illustrating the accident flight path

After departing runway 4, the local controller observed a primary target with an associated transponder code of 4254, which was the code that had been assigned to the airplane on its previous flight. The local controller observed the 4254 target climb through 4,400 ft msl and instructed the pilot to reset the transponder to 4261. The pilot reset the transponder code to 4261. The local controller observed the beacon code change from 4254 to 4261, then advised the pilot "I've got you now," and instructed him to contact AMA departure control.

Figure 1 shows the plotted AMA radar data illustrating the accident flight path. The red targets are from transponder code 4254, and the blue targets are from transponder code 4261. The last eight recorded targets are labeled with their mode C reported altitudes.

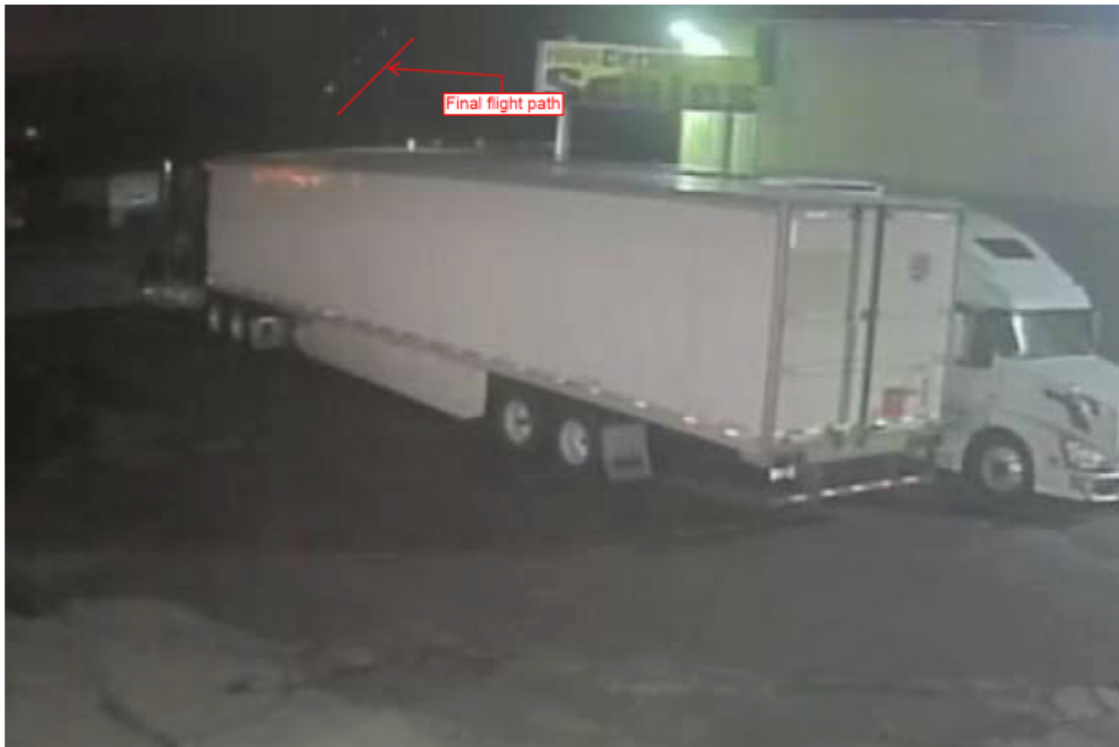
Figure 2 – Accident airplane's final flight path

Surveillance video from a nearby truck stop, located about 400 yards southwest of the accident site, recorded lights from the airplane followed by an explosion. Still images were taken from the video and layered to produce figure 2, which depicts the airplane's final flight path. The images show the airplane descending about a 45° angle to ground impact.

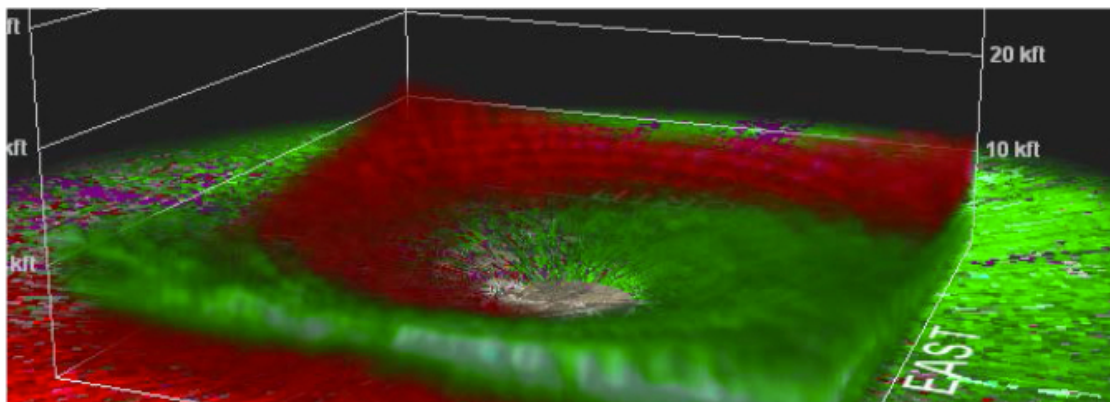
Figure 3 – Wind profile, 3D view

The warning coordination meteorologist for the National Weather Service (NWS) Weather Forecast Office (WFO) in Amarillo, Texas, provided a 3D image (figure 3, which shows AMA at the center of the 3D box) that showed a wind shear zone between 2,500 and 3,500 ft msl as seen from the AMA weather radar about 2355. The red area indicates wind away from the radar, and the green area indicates wind toward the radar. The image shows a northerly wind near the surface and a 40 to 60 knot southerly wind above 4,000 ft msl.

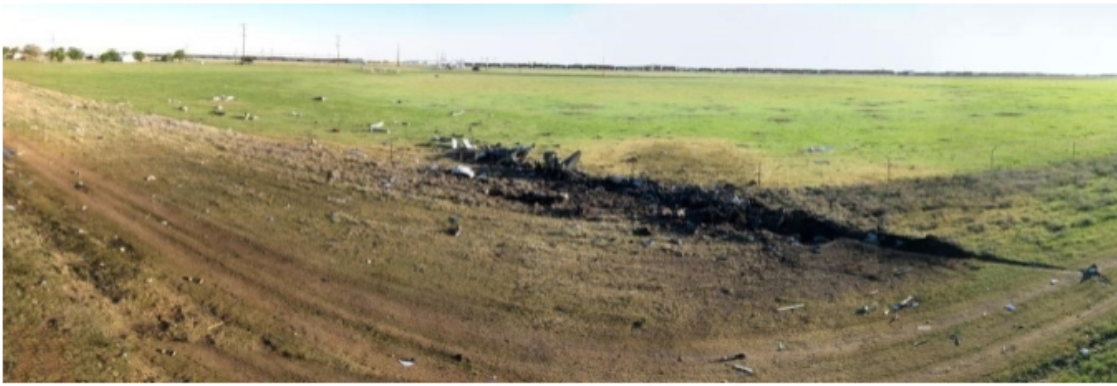
Figure 4 – Accident site viewed from the south

The airplane impacted a pasture (figure 4) adjacent to several stationary train cars about 1.5 nautical miles south of AMA, and a postimpact fire ensued. The wreckage debris path was generally oriented along a northeast-southwest line, and the airplane impacted the ground facing southwest. All major structural components of the airplane were located within the debris field.

Ground scars at the accident site and damage to the airplane were consistent with the airplane impacting in a steep, nose-low and wings-level attitude. The top soil was dark and relatively soft extending 3 to 4 ft deep, and the subsoil was a relatively hard clay. The impact crater was about 5 ft deep. A section of the left winglet, the left pitot tube, and the angle of attack sensor from the left wing were found embedded in the ground; the winglet is noticeable on the far right side of figure 4. The vertical stabilizer remained attached to the fuselage and sustained relatively minor damage compared to the rest of the airplane structure. The horizontal stabilizer separated near mid-span, and both sides were identified. The left side was severely crushed from the leading edge aft; a corresponding impact mark was observed in the ground near the center and in front of the impact crater.

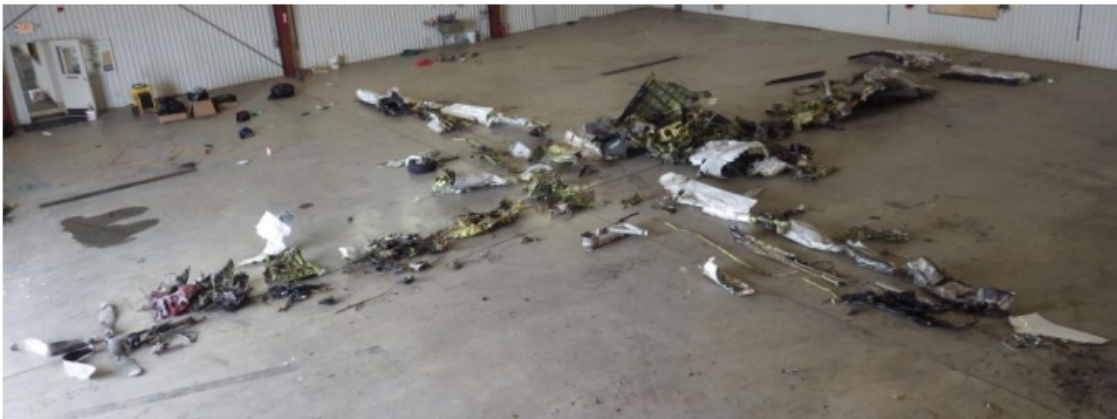
Figure 5 – Wreckage organized in hangar

The wreckage was documented at the accident site and then relocated to a secure hangar at AMA for a full layout and detailed examination. The airplane was heavily fragmented (figure 5).

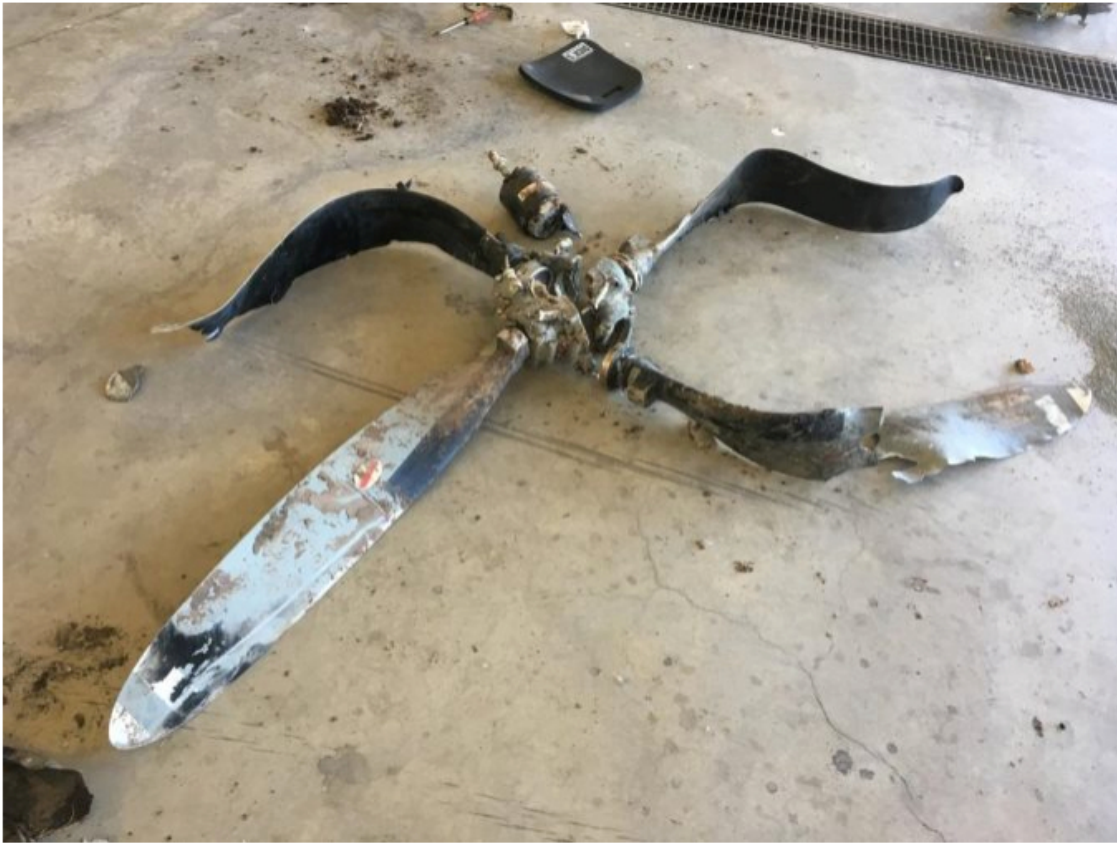
Figure 6 – Propeller

The propeller blades (figure 6) exhibited damage consistent with engine operation during impact.

There were no preimpact anomalies found that would have prevented or degraded normal propeller operation.

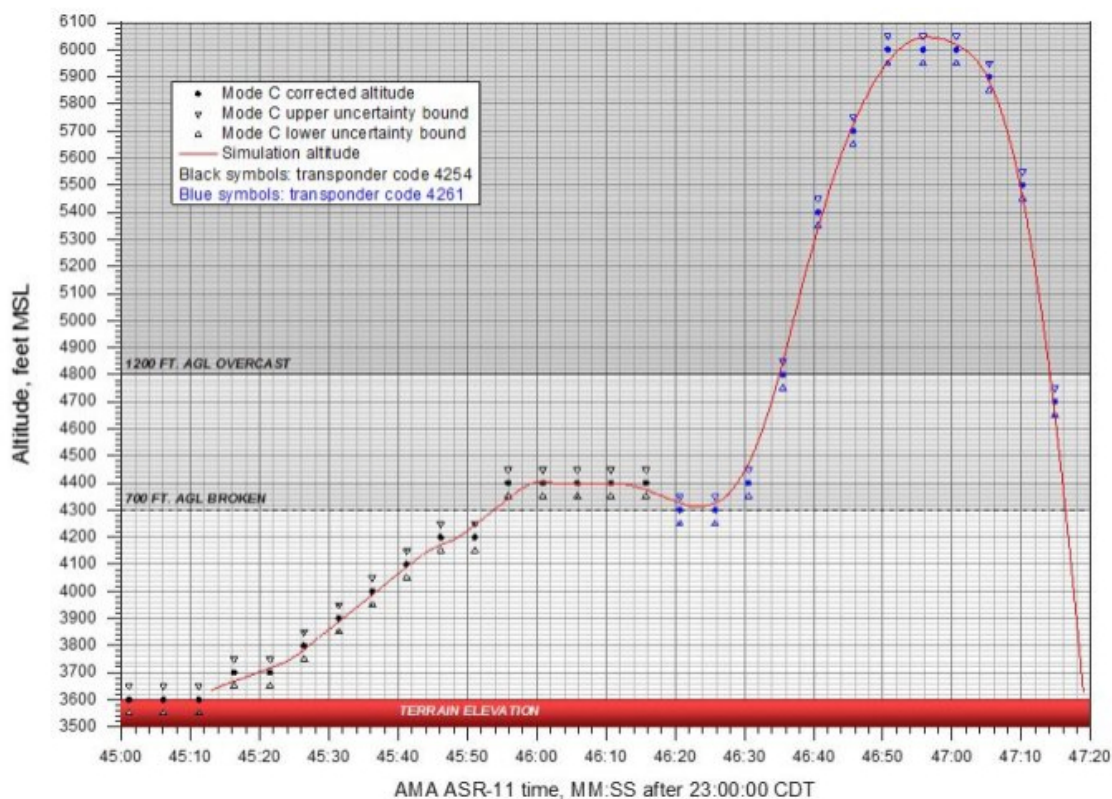
Figure 7 – Simulation of accident flight, altitude vs time graph

The simulation indicated that, after lifting off from AMA runway 4, the airplane accelerated to about 193 knots calibrated airspeed (KCAS) while climbing between 600 and 1,200 ft per minute (fpm) to an altitude of about 4,400 ft msl, or about 800 ft agl (figure 7). The airplane leveled about 4,300 to 4,400 ft msl for about 30 seconds; at 23:46:30, it resumed climbing, reaching 6,000 ft msl (2,400 ft agl) at 23:46:52. During this climb, the airplane decelerated from 193 KCAS to 122 KCAS. At 23:47:02, the airplane started an increasingly rapid descent from 6,000 ft msl to the ground (elevation 3,600 ft msl). Based on the simulation, the estimated rate of descent and airspeed at impact were about 17,000 fpm and 220 KCAS, respectively. The estimated time of impact was 23:47:19.

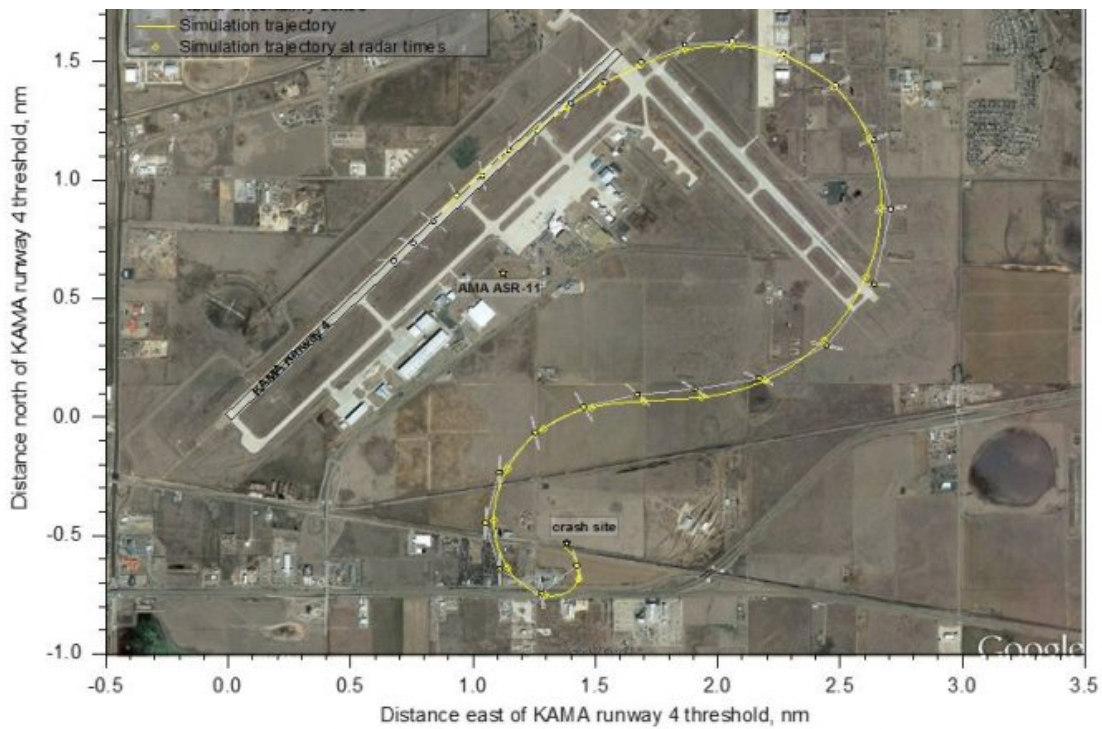
Figure 8 – Google Earth view of radar data and simulation trajectory

At 23:45:42, while climbing through 4,100 ft msl (500 ft agl), the airplane started a slow right roll (figure 8), reaching a roll angle of about 42° at 23:46:10. At 23:46:24, the roll angle had decreased to 36°, and the pitch angle started to increase steadily, which was consistent with the climb to 6,000 ft msl. At 23:46:32, when the roll angle was 30°, the airplane started rolling more quickly to the left, rolling through wings level at 23:46:40, then on a ground track of 267° true.

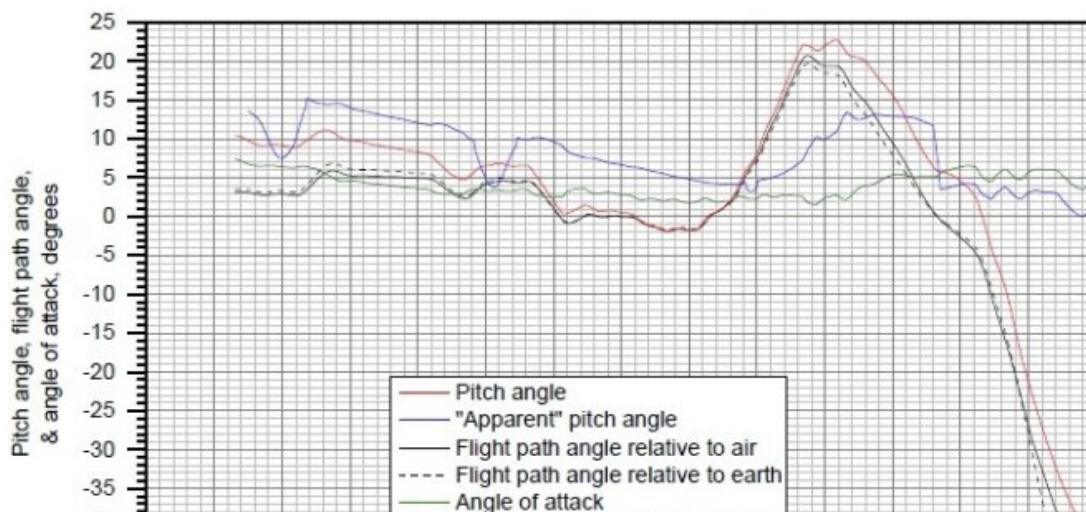
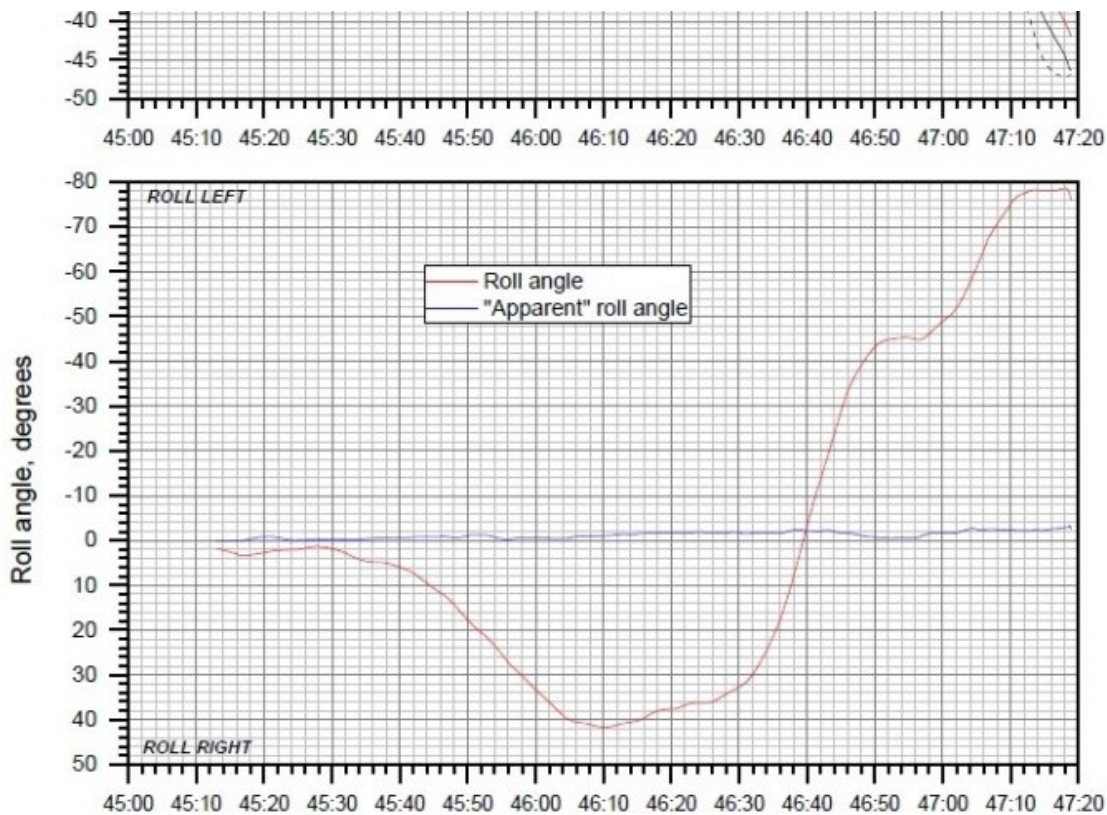
AMA ASR-11 time, MM:SS after 23:00:00 CDT
 Figure 9 – Simulation apparent pitch and roll angles

The airplane achieved a peak pitch angle of about 23° at 23:46:42 (figure 9), after which the pitch angle decreased steadily to an estimated -42° at impact. As the pitch angle decreased, the roll angle increased steadily to the left, reaching an estimated -76° at impact.

An estimate of the "apparent" pitch and roll angles, which represent the attitude a pilot would "feel" the airplane to be in based on his vestibular/kinesthetic perception of the components of the load factor vector in his own body coordinate system, was made based on the simulation load factors. The "apparent" pitch angle ranged between 0° and 15°, and the "apparent" roll angle ranged between 0° and -4° (figure 9).
