National Transportation Safety Board Aviation Accident Final Report

Location:	Hydaburg, AK	Accident Number:	ANC18FA053
Date & Time:	07/10/2018, 0835 AKD	Registration:	N3952B
Aircraft:	De Havilland DHC 3	Aircraft Damage:	Substantial
Defining Event:	Loss of visual reference	Injuries:	6 Serious, 4 Minor, 1 None
Flight Conducted Under:	Part 135: Air Taxi & Commuter - Non-scheduled

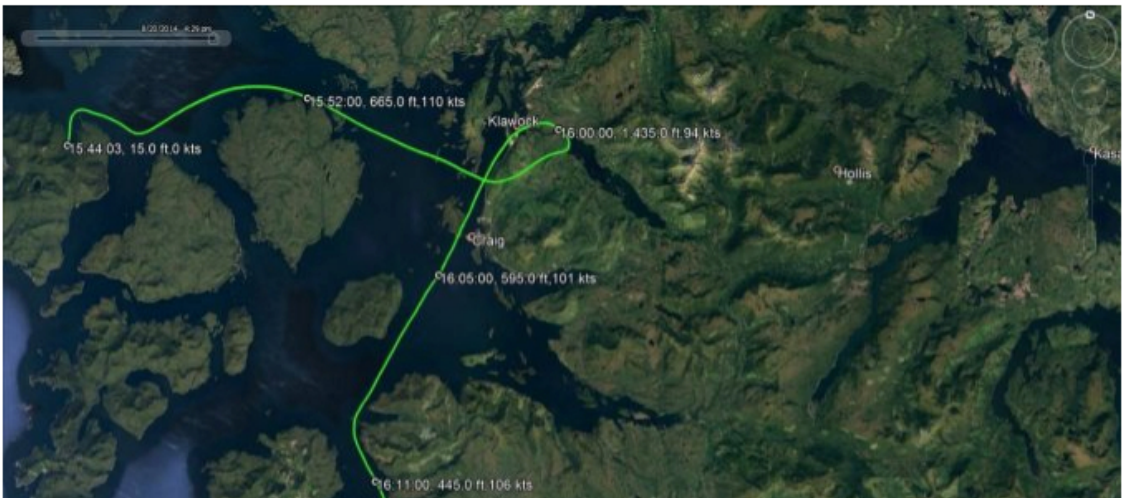
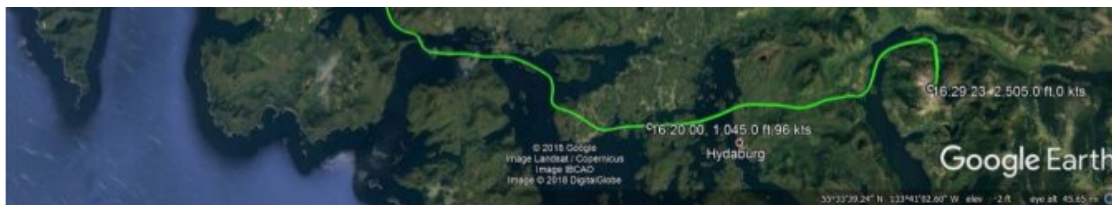
Figure 1. Google Earth overlay of the entire accident flight on July 10, 2018. Indicated airspeed (IAS) values are shown.
