AVIATION ACCIDENT INVESTIGATION REPORT

RUNWAY OVERRUN ON LANDING

FLIGHT AA331

BOEING 737-823

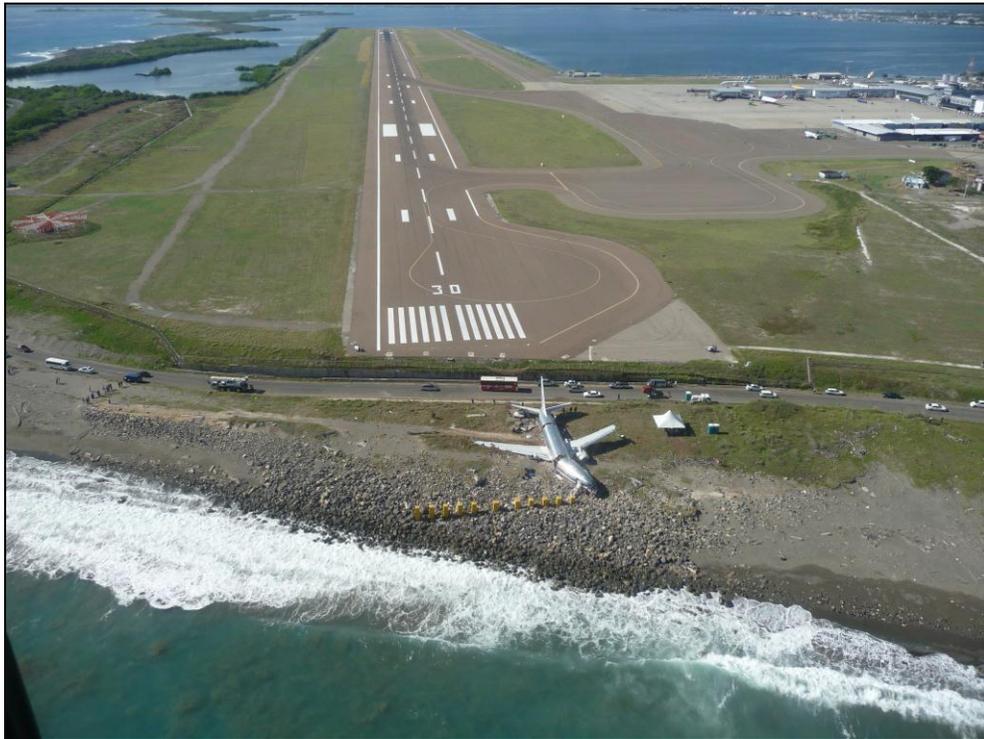
Photo 1 Aerial Photograph of Accident Site

There was no post-crash fire. The aircraft was destroyed, its fuselage broken into three sections, while the left landing gear collapsed. The right engine and landing gear were torn off, the left wingtip was badly damaged and the right wing fuel tanks were ruptured, leaking jet fuel onto the beach sand.

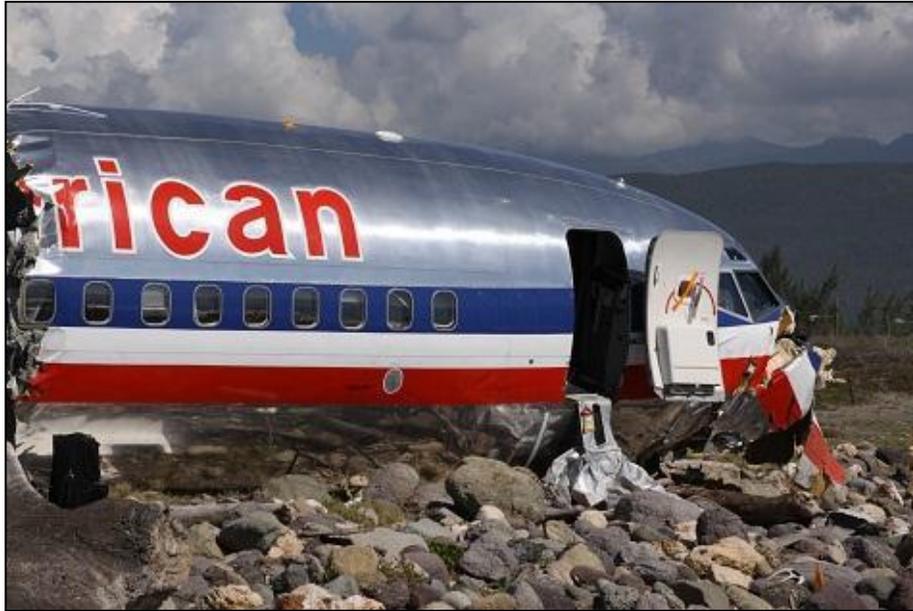
Photo 3 Forward Fuselage

Of the three sections into which the aircraft broke, the forward section consisted of the flight deck, the forward cabin crew seats, and passenger seats from rows three through six. The centre section contained passenger seat rows 7 through 22, including the four over wing emergency exits. The aft section consisted of the aft fuselage of the aircraft from passenger seat row 23 through to the tail of the aircraft.

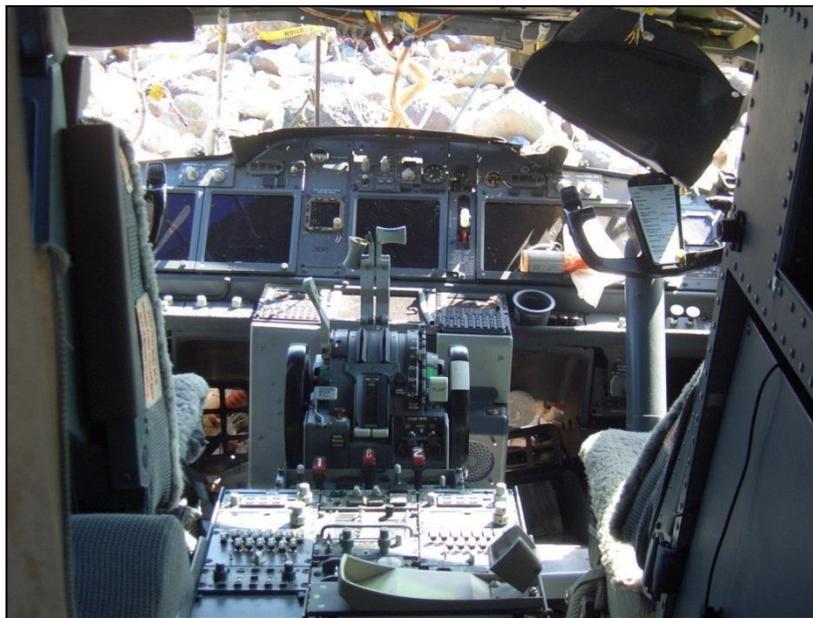
Photo 15 View into Flight Deck

Both the captain and first officer's seats were subjected to high horizontal forces during the impact. A mathematical calculation was conducted by IPECO, manufacturer of the flight deck seats, and it was estimated that the G-loads during the impact sequence were between 10 and 12.7 G for a forward deceleration.

The captain's seat crotch belt was found broken loose from the seat structure because the captain's crotch belt bracket was broken.⁴⁷ Both the crotch belt and the outboard shoulder harness were found buckled. The captain's outboard shoulder harness was locked in the extended position and the inboard shoulder harness retracted normally.
