2014 UT Law Car Crash Seminar: From Sign-Up to Settlement

WHEN A CAR WRECK ISN'T JUST A CAR WRECK

Mike Davis Slack & Davis, L.L.P.

Auto Product Liability & Truck Crash Cases

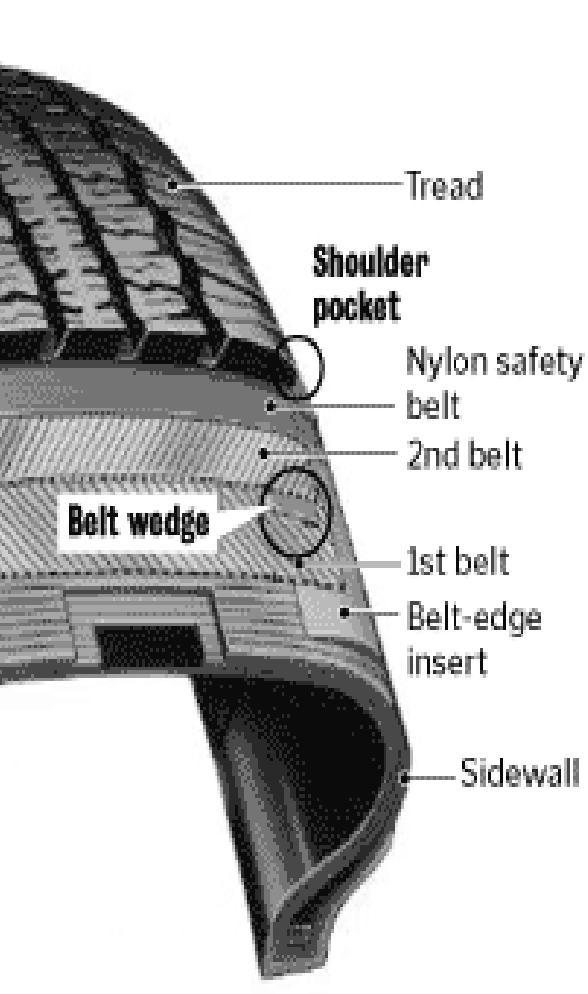
Tread Separation

Belt wedge

A design feature used to supress belt-edge cracks is the "belt wedge," a strip of rubber between the two belts. The thickness of belts used in ATX and Wilderness AT tires produced prior to May 1998 was typically less than other tires. Firestone's shoulder pocket design also caused stress at the tire's belt-edge.

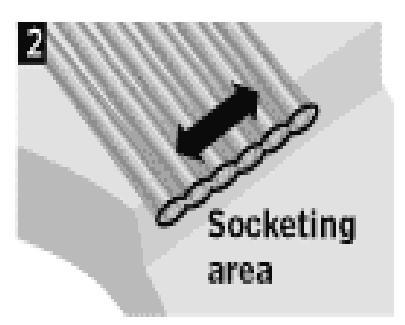
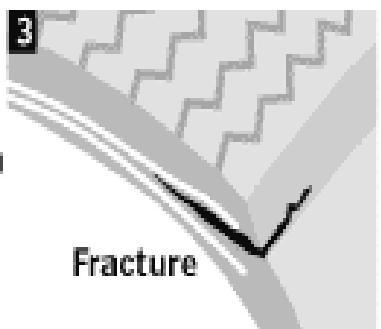
Belt separation

A defect known as socketing begins at the ends of the belts, because the cut ends of the belt wire are not brass coated. Rubber will not adhere to bare wire.

As the belt moves, the socketing area grows.

A fracture develops between the two belts from shear stresses, around the tire and from side to side.
